**Flood Control Project Maintenance  
Levee Inspections**

**Fall 2019 Levee Maintenance Deficiency Summary Report**

**Sacramento River Basin**

**Lake County Watershed Protection District**

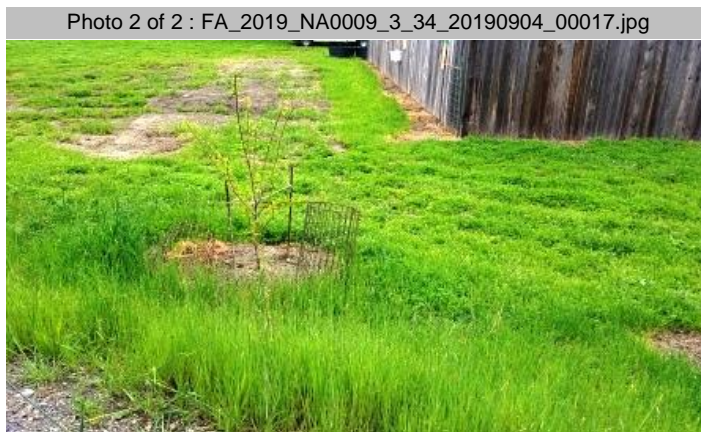
LM Start	<b>0.30</b>	Rating **	M	Issue No.	<b>34 (cont)</b>
LM End	<b>0.30</b>	Issue Type +	En	Location *	LS

View of newly planted trees within landside toe easement. Spring 2019

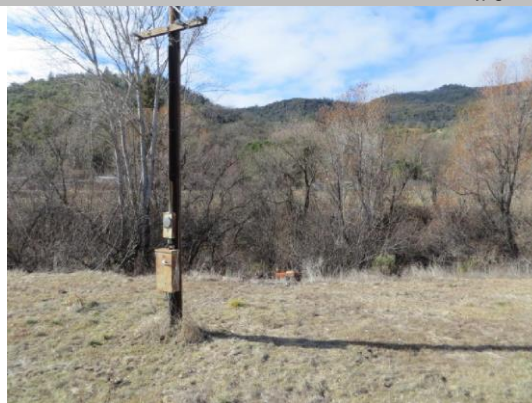
Photo 2 of 3 : UCIP\_FA\_2019\_55696\_49781.jpg

Comment Code					
Inspector Comment					
DS_ID:21193 FS_ID:55696 EP_NO: 5237 Repair Type: Non-Urgent Crossing Status: Found UCIP Comments: 10/16/2019 Record remains Non-Urgent; crossing has been abandoned. Owner will need to coordinate with CVFPB to remove or abandon crossing per Title 23 requirements. The UCIP inspection was completed with DWR Inspector, L. Dial, and LMA representative, S. Webb. (O. Magana - DWR UCIP)01/09/2014 Pipe appears abandoned and should be done so properly. (W. Wylie - DWR UCIP) FIELD_STRUCT_DESC: *ABANDONED* 6-inch coated steel irrigation pipe possibly sleeved through an 8-inch steel pipe, 3 feet below the crown. Siphon breaker in 24-inch corrugated metal riser unit on the landside (LS) slope. Reinforced concrete cutoff wall at center of levee. Butterfly valve on the waterside (WS) at pump on concrete base on the WS bank. Pole on the WS berm with overhead power line supplying electricity to the pump. (Installed under Permit No. 5237, 1966 - Moitozo Brothers, Inc.). [Additional Reference(s): DWR Levee Log, 2005. USACE Sacramento O&M Manual 506.2, August 1961, (HLM 0.54), Station M296+75, 8-inch pipe, dwg no. CC-4-4-29, Index Sheet 6: page 6, 40 of 64]. FS Date: 10/16/2019 3:57:00 PM

Power pole, meter, and pump visible on WS berm.

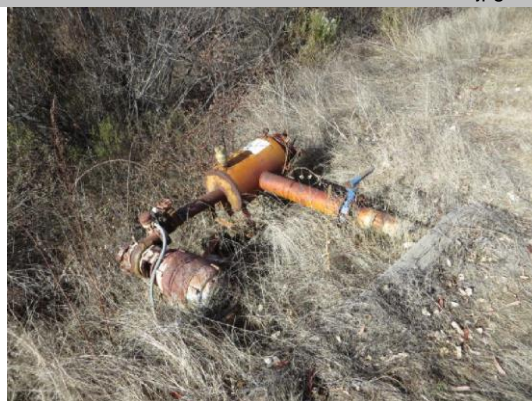
Photo 3 of 3 : UCIP\_FA\_2019\_55696\_49780.jpg

Comment Code						
Inspector Comment						
DS_ID:21193 FS_ID:55696 EP_NO: 5237 Repair Type: Non-Urgent Crossing Status: Found UCIP Comments: 10/16/2019 Record remains Non-Urgent; crossing has been abandoned. Owner will need to coordinate with CVFPB to remove or abandon crossing per Title 23 requirements. The UCIP inspection was completed with DWR Inspector, L. Dial, and LMA representative, S. Webb. (O. Magana - DWR UCIP)01/09/2014 Pipe appears abandoned and should be done so properly. (W. Wylie - DWR UCIP) FIELD_STRUCT_DESC: *ABANDONED* 6-inch coated steel irrigation pipe possibly sleeved through an 8-inch steel pipe, 3 feet below the crown. Siphon breaker in 24-inch corrugated metal riser unit on the landside (LS) slope. Reinforced concrete cutoff wall at center of levee. Butterfly valve on the waterside (WS) at pump on concrete base on the WS bank. Pole on the WS berm with overhead power line supplying electricity to the pump. (Installed under Permit No. 5237, 1966 - Moitozo Brothers, Inc.). [Additional Reference(s): DWR Levee Log, 2005. USACE Sacramento O&M Manual 506.2, August 1961, (HLM 0.54), Station M296+75, 8-inch pipe, dwg no. CC-4-4-29, Index Sheet 6: page 6, 40 of 64]. FS Date: 10/16/2019 3:57:00 PM

Pump and butterfly valve on WS berm.

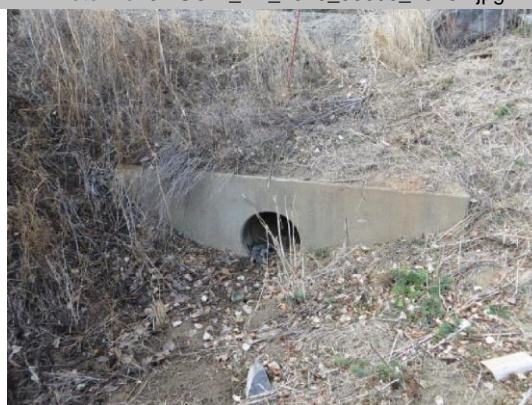
Photo 2 of 3 : UCIP\_FA\_2019\_55693\_49784.jpg

Comment Code					
Inspector Comment					
DS_ID:21194 FS_ID:55693 EP_NO: 11468 Repair Type: Non-Urgent Crossing Status: Found UCIP Comments: 10/16/2019 Record has been updated from No Action Needed to Non-Urgent; need to audit record to confirm owner. Crossing has been internally inspected under the DWR DMP Phase 1 project. Inspection report is still not available. The UCIP inspection was completed with DWR Inspector, L. Dial, and LMA representative, S. Webb. (O. Magana - DWR UCIP) FIELD_STRUCT_DESC: 24-inch corrugated metal drainage pipe through the levee, 8 feet below the crown. Flap gate on the waterside (WS) end. Concrete headwalls on both ends. (Pipe retained through the levee under Automatic Board Order (ABO) issued as Permit No. 11468, 1975 - Moitozo Brothers, Inc.). [Additional Reference(s): DWR Levee Log, 2005. USACE Sacramento O&M Manual 506.2, August 1961, Station M293+50, 24-inch pipe, dwg no. CC-4-4-29, Index Sheet 6: page 6, 40 of 64]. FS Date: 10/16/2019 3:58:00 PM

Drain pipe visible at concrete headwall on LS toe.

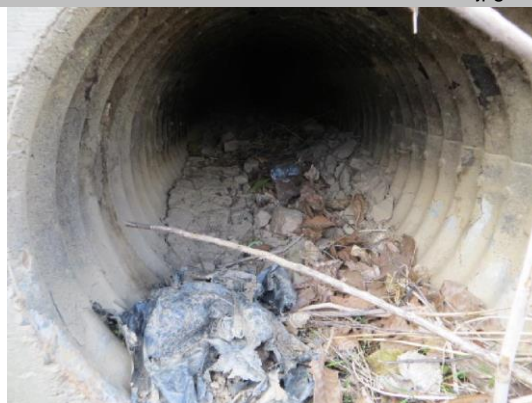
Photo 3 of 3 : UCIP\_FA\_2019\_55693\_49783.jpg

Comment Code					
Inspector Comment					
DS_ID:21194 FS_ID:55693 EP_NO: 11468 Repair Type: Non-Urgent Crossing Status: Found UCIP Comments: 10/16/2019 Record has been updated from No Action Needed to Non-Urgent; need to audit record to confirm owner. Crossing has been internally inspected under the DWR DMP Phase 1 project. Inspection report is still not available. The UCIP inspection was completed with DWR Inspector, L. Dial, and LMA representative, S. Webb. (O. Magana - DWR UCIP) FIELD_STRUCT_DESC: 24-inch corrugated metal drainage pipe through the levee, 8 feet below the crown. Flap gate on the waterside (WS) end. Concrete headwalls on both ends. (Pipe retained through the levee under Automatic Board Order (ABO) issued as Permit No. 11468, 1975 - Moitoyo Brothers, Inc.). [Additional Reference(s): DWR Levee Log, 2005. USACE Sacramento O&M Manual 506.2, August 1961, Station M293+50, 24-inch pipe, dwg no. CC-4-4-29, Index Sheet 6: page 6, 40 of 64]. FS Date: 10/16/2019 3:58:00 PM

CMP as visible from LS toe.

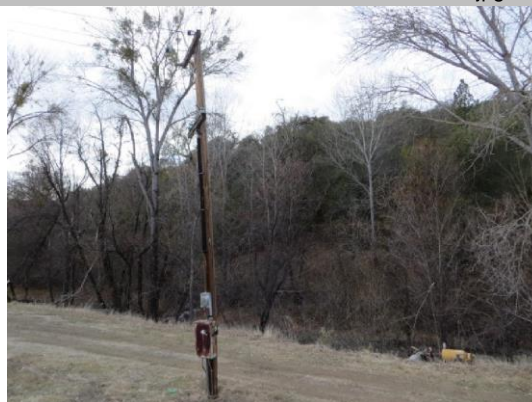
Photo 2 of 3 : UCIP\_FA\_2019\_55697\_49788.jpg

Comment Code					
Inspector Comment					
DS_ID:21196 FS_ID:55697 EP_NO: N/A Repair Type: Non-Urgent Crossing Status: Found UCIP Comments: 10/16/2019 Record remains Non-Urgent; crossing has been abandoned. Owner will need to coordinate with CVFPB to remove or abandon crossing per Title 23 requirements. The UCIP inspection was completed with DWR Inspector, L. Dial, and LMA representative, S. Webb. (O. Magana - DWR UCIP)01/09/2014 Pump and pipe appear abandoned and should be done so properly. (W. Wylie - DWR UCIP) FIELD_STRUCT_DESC: *ABANDONED* 8-inch steel irrigation pipe through the levee, 3 feet below the crown. Siphon breaker in 24-inch corrugated metal riser unit on the landside (LS) slope. Pump on the waterside (WS) bank with a butterfly valve. Service pole on the WS berm. (Moitozo Brothers, Inc.). [Additional Reference(s): DWR Levee Log, 2005. USACE Sacramento O&M Manual 506.2, August 1961, (HLM 0.83), Station M281+70, 8-inch pipe, dwg no. CC-4-4-29, Index Sheet 5: page 5, 39 of 64]. FS Date: 10/16/2019 3:59:00 PM

Pump, pole, and meter on WS berm.

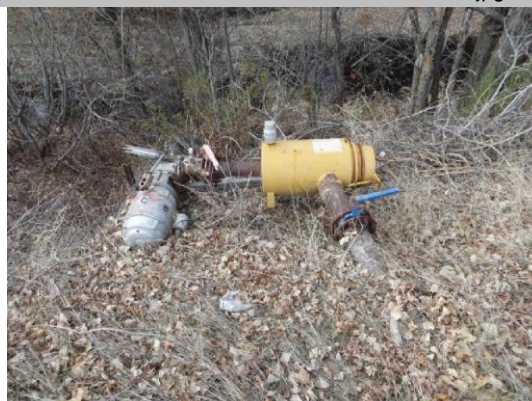
Photo 3 of 3 : UCIP\_FA\_2019\_55697\_49787.jpg

Comment Code						
Inspector Comment						
DS_ID:21196 FS_ID:55697 EP_NO: N/A Repair Type: Non-Urgent Crossing Status: Found UCIP Comments: 10/16/2019 Record remains Non-Urgent; crossing has been abandoned. Owner will need to coordinate with CVFPB to remove or abandon crossing per Title 23 requirements. The UCIP inspection was completed with DWR Inspector, L. Dial, and LMA representative, S. Webb. (O. Magana - DWR UCIP)01/09/2014 Pump and pipe appear abandoned and should be done so properly. (W. Wylie - DWR UCIP) FIELD_STRUCT_DESC: *ABANDONED* 8-inch steel irrigation pipe through the levee, 3 feet below the crown. Siphon breaker in 24-inch corrugated metal riser unit on the landside (LS) slope. Pump on the waterside (WS) bank with a butterfly valve. Service pole on the WS berm. (Moitozo Brothers, Inc.). [Additional Reference(s): DWR Levee Log, 2005. USACE Sacramento O&M Manual 506.2, August 1961, (HLM 0.83), Station M281+70, 8-inch pipe, dwg no. CC-4-4-29, Index Sheet 5: page 5, 39 of 64]. FS Date: 10/16/2019 3:59:00 PM

Pump and butterfly valve visible on WS berm.

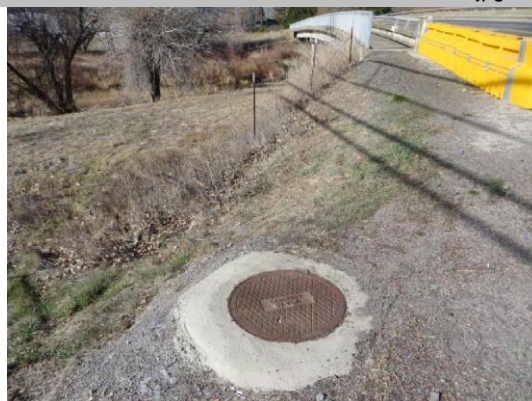
Photo 1 of 1 : UCIP\_FA\_2019\_55700\_49870.jpg

Comment Code					
Inspector Comment					
DS_ID:21241 FS_ID:55700 EP_NO: 15865 Repair Type: Non-Urgent Crossing Status: Indicator Found UCIP Comments: 10/16/2019 Record has been updated from No Action Needed to Non-Urgent, unable to confirm alignment; permit recordation notes pipe was never installed from 1983 to 1999 due to property litigation. 03-10-1999 permit owner requested permit stay active. Recommend auditing permit to confirm if pipe was ever installed. (O. Magana - DWR UCIP) FIELD_STRUCT_DESC: 6-inch polyvinyl chloride pressurized sewer line through the levee, 3 feet below the crown. Cutoff wall around pipe at center of levee. Sanitary Sewer manhole on the waterside (WS) shoulder. (6-inch pipe authorized under Permit No. 15865, 1992 - Zachary Calhoun). FS Date: 10/16/2019 3:56:00 PM

SS manhole visible on WS shoulder.

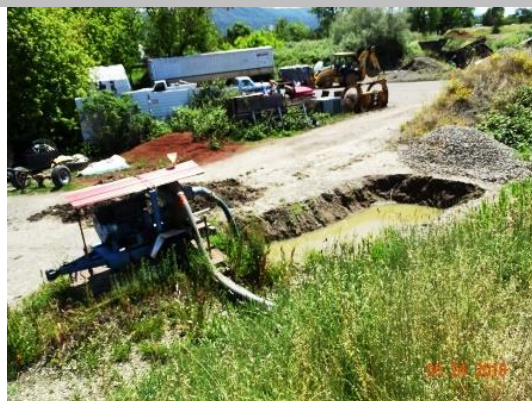
Photo 1 of 2 : FA\_2019\_NA0009\_3\_45\_20190904\_00018.jpg

LM Start	2.10	Rating **	U	Issue No.	45
LM End	2.10	Issue Type +	En	Location *	LS
Category	Earthen Levee			GPS Latitude/Longitude	
				Start	End
Item	Encroachments			39.162198°	39.162198°
				-122.915488°	-122.915488°
DWR ID	DWR_NA0009_01_s_2019_45				
Comment Code					
DT : Ditch					
Inspector Comment					
The landowner dug a pit approximately 24' x 12' x 3' within the theoretical levee prism and ran a metal pump hose over the crown.

View looking downstream at a storage pit dug into the levee prism. Spring 2019

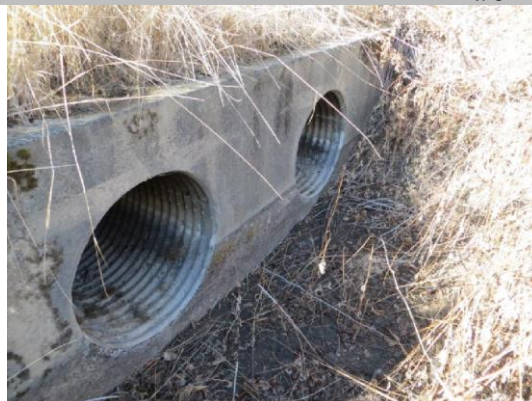
Photo 2 of 3 : UCIP\_FA\_2019\_55702\_49852.jpg

Comment Code					
Inspector Comment					
DS_ID:21240 FS_ID:55702 EP_NO: 11460 Repair Type: Non-Urgent Crossing Status: Found UCIP Comments: 10/16/2019 Record has been updated from No Action Needed to Non-Urgent; need to audit record to confirm owner. Crossing has been internally inspected under the DWR DMP Phase 1 project. Inspection report is still not available. The UCIP inspection was completed with DWR Inspector, L. Dial, and LMA representative, S. Webb. (O. Magana - DWR UCIP) FIELD_STRUCT_DESC: 1 of 2: 36-inch corrugated metal drainage pipe through the levee, 9 feet below the crown. Flap gate on the waterside (WS) end. Concrete headwalls on both ends. (two 36-inch pipes [HLM 2.26] retained under Automatic Board Order (ABO) issued as Permit No. 11460, 1975 - Robert L. and Lavona Gentry). [Additional Reference(s): DWR Levee Log, 2005. USACE Sacramento O&M Manual 506.2, August 1961, (HLM 2.26), Station M206+00, two 36-inch pipes, dwg no. CC-4-4-29, Index Sheet 4: page 4, 38 of 64]. FS Date: 10/16/2019 3:56:00 PM

Pipe and Concrete headwall visible on LS toe.

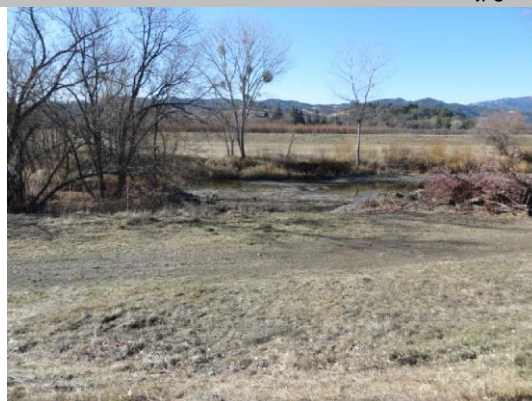
Photo 3 of 3 : UCIP\_FA\_2019\_55702\_49851.jpg

Comment Code						
Inspector Comment						
DS_ID:21240 FS_ID:55702 EP_NO: 11460 Repair Type: Non-Urgent Crossing Status: Found UCIP Comments: 10/16/2019 Record has been updated from No Action Needed to Non-Urgent; need to audit record to confirm owner. Crossing has been internally inspected under the DWR DMP Phase 1 project. Inspection report is still not available. The UCIP inspection was completed with DWR Inspector, L. Dial, and LMA representative, S. Webb. (O. Magana - DWR UCIP) FIELD_STRUCT_DESC: 1 of 2: 36-inch corrugated metal drainage pipe through the levee, 9 feet below the crown. Flap gate on the waterside (WS) end. Concrete headwalls on both ends. (two 36-inch pipes [HLM 2.26] retained under Automatic Board Order (ABO) issued as Permit No. 11460, 1975 - Robert L. and Lavona Gentry). [Additional Reference(s): DWR Levee Log, 2005. USACE Sacramento O&M Manual 506.2, August 1961, (HLM 2.26), Station M206+00, two 36-inch pipes, dwg no. CC-4-4-29, Index Sheet 4: page 4, 38 of 64]. FS Date: 10/16/2019 3:56:00 PM

Pipe, Concrete headwall, and flap gate visible on WS berm.

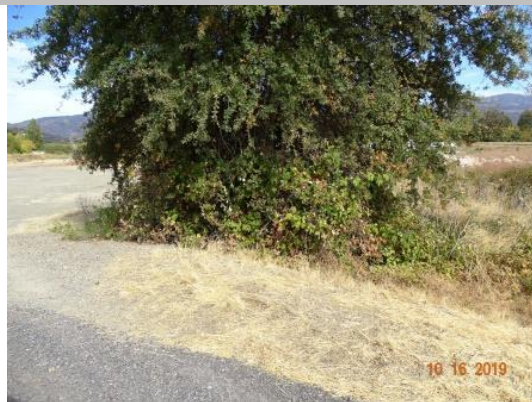
Photo 1 of 1 : FA\_2019\_NA0009\_3\_46\_20191022\_00042.jpg

LM Start	2.26	Rating **	M	Issue No.	46
LM End	2.40	Issue Type +	Ma	Location *	LS
Category	Earthen Levee			GPS Latitude/Longitude	
				Start	End
Item	Vegetation			39.160325 °	39.161655 °
				-122.913980 °	-122.912262 °
DWR ID	DWR_NA0009_01_s_ 2019_46				
Comment Code					
V2 : Remove the wild growth other than native grasses from the levee slopes.					
Inspector Comment

View of wild growth on the landside slope. Fall 2019

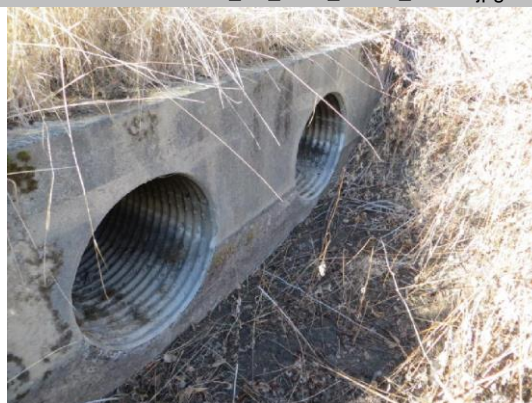
Photo 2 of 3 : UCIP\_FA\_2019\_55703\_49848.jpg

Comment Code						
Inspector Comment						
DS_ID:21197 FS_ID:55703 EP_NO: 11460 Repair Type: Non-Urgent Crossing Status: Found UCIP Comments: 10/16/2019 Record has been updated from No Action Needed to Non-Urgent; need to audit record to confirm owner. Crossing has been internally inspected under the DWR DMP Phase 1 project. Inspection report is still not available. The UCIP inspection was completed with DWR Inspector, L. Dial, and LMA representative, S. Webb. (O. Magana - DWR UCIP) FIELD_STRUCT_DESC: 2 of 2: 36-inch corrugated metal drainage pipe through the levee, 9 feet below the crown. Flap gate on the waterside (WS) end. Concrete U-shaped headwalls on both ends. (two 36-inch pipes [HLM 2.26] retained under Automatic Board Order (ABO) issued as Permit No. 11460, 1975 - Robert L. and Lavona Gentry). [Additional Reference(s): DWR Levee Log, 2005. USACE Sacramento O&M Manual 506.2, August 1961, (HLM 2.26), Station M206+00, two 36-inch pipes, dwg no. CC-4-4-29, Index Sheet 4: page 4, 38 of 64]. FS Date: 10/16/2019 3:59:00 PM

Concrete headwall and pipe visible on LS toe.

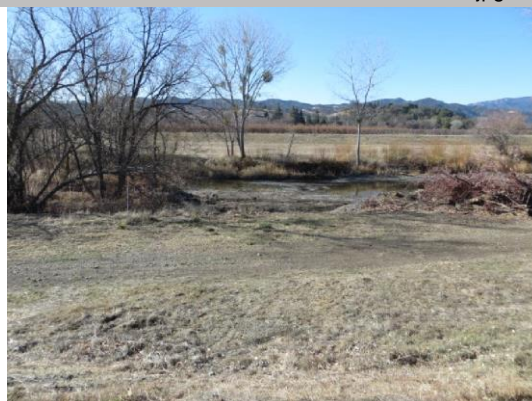
Photo 3 of 3 : UCIP\_FA\_2019\_55703\_49847.jpg

Comment Code						
Inspector Comment						
DS_ID:21197 FS_ID:55703 EP_NO: 11460 Repair Type: Non-Urgent Crossing Status: Found UCIP Comments: 10/16/2019 Record has been updated from No Action Needed to Non-Urgent; need to audit record to confirm owner. Crossing has been internally inspected under the DWR DMP Phase 1 project. Inspection report is still not available. The UCIP inspection was completed with DWR Inspector, L. Dial, and LMA representative, S. Webb. (O. Magana - DWR UCIP) FIELD_STRUCT_DESC: 2 of 2: 36-inch corrugated metal drainage pipe through the levee, 9 feet below the crown. Flap gate on the waterside (WS) end. Concrete U-shaped headwalls on both ends. (two 36-inch pipes [HLM 2.26] retained under Automatic Board Order (ABO) issued as Permit No. 11460, 1975 - Robert L. and Lavona Gentry). [Additional Reference(s): DWR Levee Log, 2005. USACE Sacramento O&M Manual 506.2, August 1961, (HLM 2.26), Station M206+00, two 36-inch pipes, dwg no. CC-4-4-29, Index Sheet 4: page 4, 38 of 64]. FS Date: 10/16/2019 3:59:00 PM

Concrete headwall and pipe visible on WS berm.

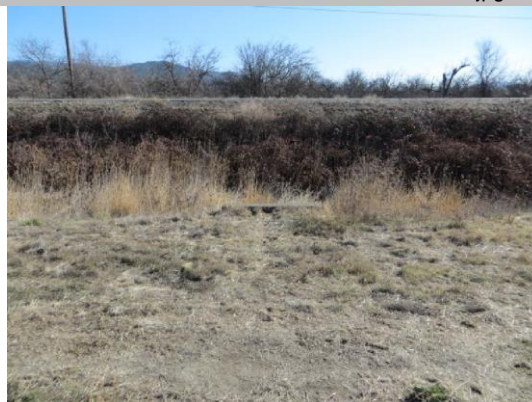
Photo 2 of 3 : UCIP\_FA\_2019\_55705\_49861.jpg

Comment Code						
Inspector Comment						
DS_ID:21199						
FS_ID:55705						
EP_NO: 11460						
Repair Type: Non-Urgent						
Crossing Status: Found						
UCIP Comments: 10/16/2019 Record remains Non-Urgent, need to audit record to confirm owner. Crossing has been internally inspected under the DWR DMP Phase 1 project. Inspection report is still not available. The UCIP inspection was completed with DWR Inspector, L. Dial, and LMA representative, S. Webb. (O. Magana - DWR UCIP)01/14/2014 Heavy vegetation on LS at inlet should be remove. (W. Wylie - DWR UCIP)						
FIELD_STRUCT_DESC: 42-inch corrugated metal drainage pipe through the levee, 10 feet below the crown. Flap gate on the waterside (WS) end. Concrete headwall on both ends. (42-inch pipe [HLM 2.35] retained under Automatic Board Order (ABO) issued as Permit No. 11460, 1975 - Robert L. and Lavona Gentry). [Additional Reference(s): DWR Levee Log, 2005. USACE Sacramento O&M Manual 506.2, August 1961, (HLM 2.35), Station C4+90, 42-inch pipe, dwg no. CC-4-4-29, Index Sheet 4: page 4, 38 of 64].

Concrete U-shaped headwall on WS berm.

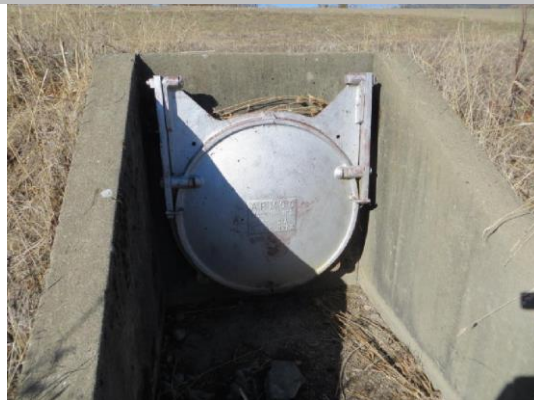
Photo 3 of 3 : UCIP\_FA\_2019\_55705\_49860.jpg

Concrete U-shaped headwall and flap gate on WS berm.

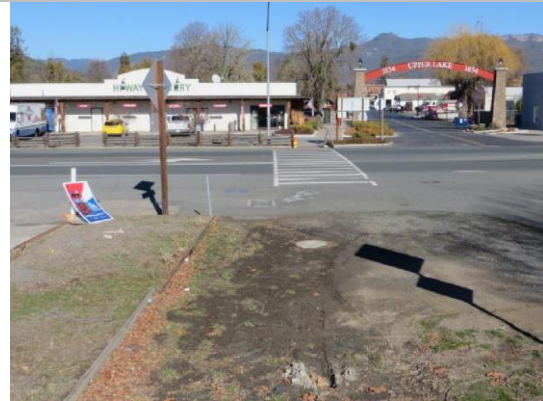
Photo 3 of 3 : UCIP\_FA\_2019\_55707\_50040.jpg

Stormdrain drop inlet visible at edge of pavement on HWY 20.

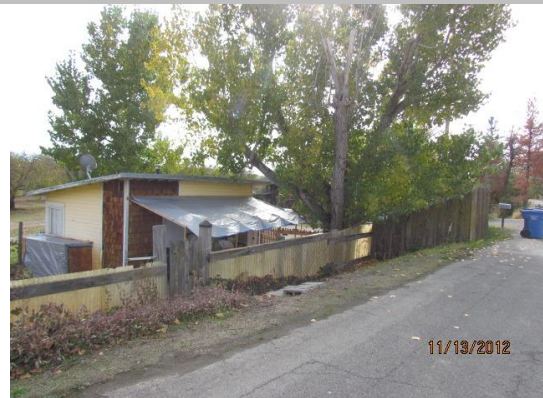
Photo 1 of 1 : FA\_2019\_NA0009\_3\_7\_20190904\_00005.jpg

View of a building & fence along the toe of the levee. Fall 2012

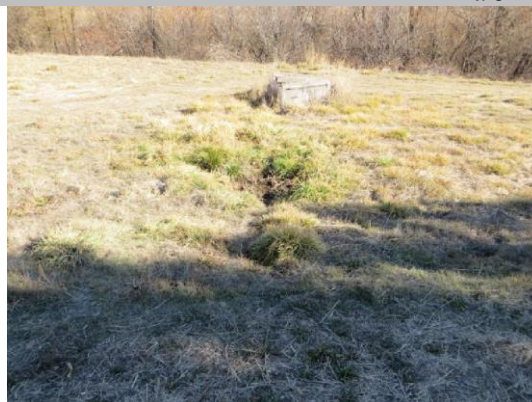
Photo 2 of 3 : UCIP\_FA\_2019\_55728\_50392.jpg

Mudpit at WS berm were pipe may be leaking.

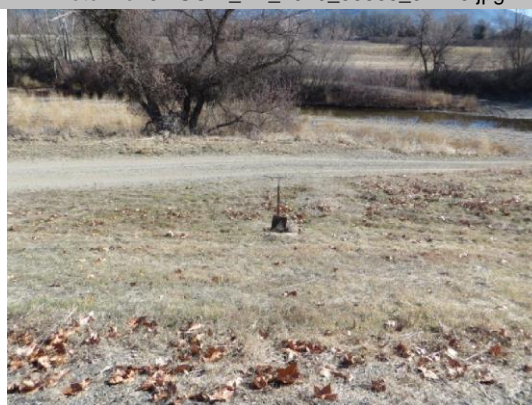
Photo 2 of 3 : UCIP\_FA\_2019\_55865\_51249.jpg

T-post at WS toe may indicate location of pipe end. Covered with soil.

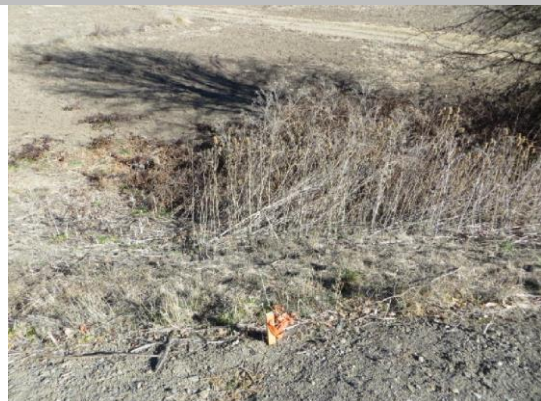
Photo 1 of 3 : UCIP\_FA\_2019\_55769\_51542.jpg

Pipe visible at LS toe covered with vegetation.

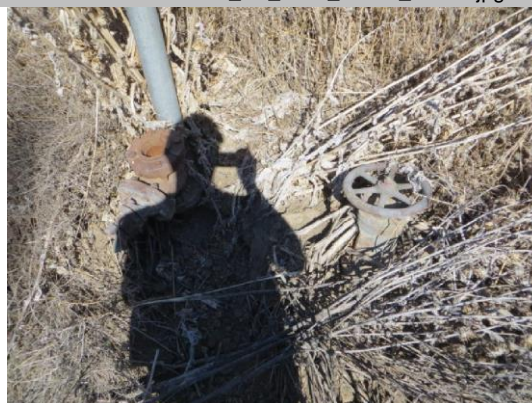
Photo 2 of 3 : UCIP\_FA\_2019\_55783\_51621.jpg

Gate valves at tank appear to be in disrepair.

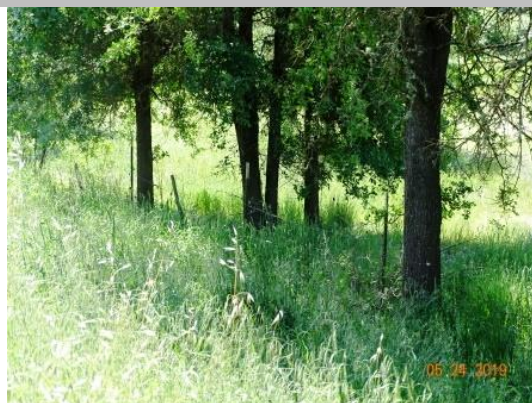
Photo 1 of 1 : FA\_2019\_NA0009\_5\_26\_20190904\_00005.jpg

View looking downstream at wire fence along the levee toe. Spring 2019

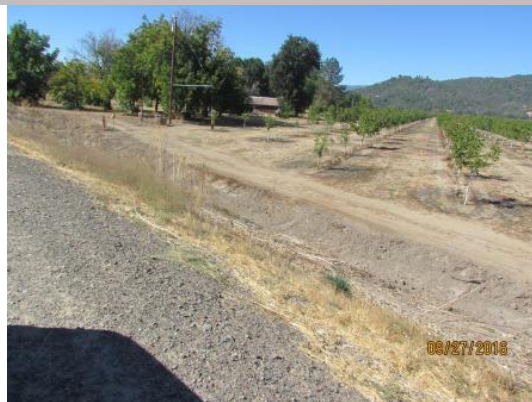
Photo 1 of 1 : FA\_2019\_NA0009\_6\_13\_20190904\_00004.jpg

View of a ditch at the landside toe looking downstream. Spring 2016

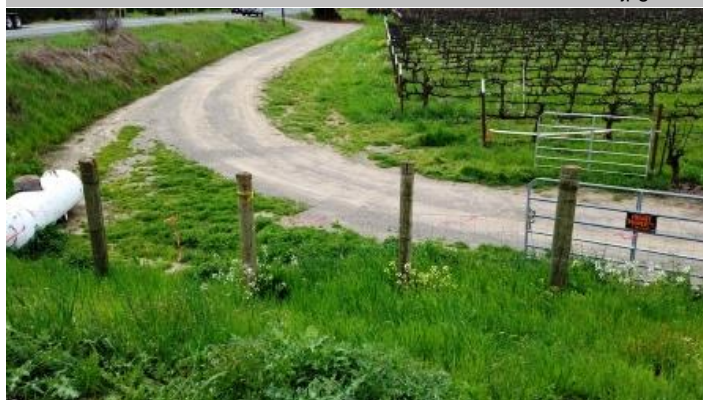
Photo 1 of 1 : FA\_2019\_NA0009\_7\_22\_20190904\_00010.jpg

View of landowner's fence posts placed at levee toe. Spring 2019
